PROJECT COMPLETED TO IMPROVE FOUNTAIN CREEK

Southern Delivery System Fact Sheet

FOUNTAIN CREEK IMPROVEMENT PROJECT

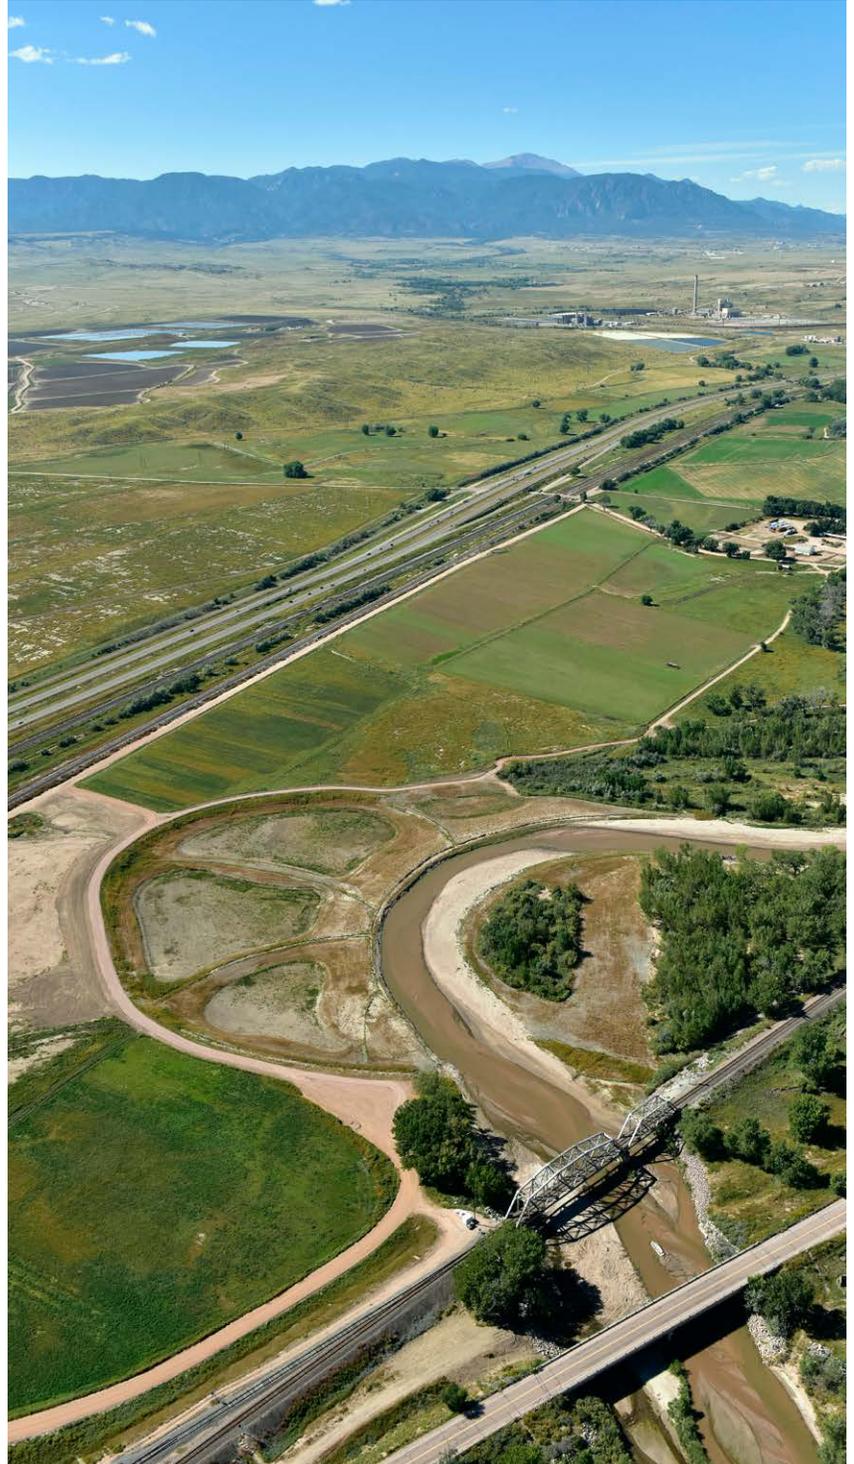
- 1. CREEK REALIGNMENT**
(RESTORING NATURAL CREEK PATTERN)
- 2. GRADING/TERRACING OF CHANNEL & BANKS**
(EROSION AND SEDIMENT CONTROL)
- 3. CHANNEL GRADE CONTROL**
(CONSTRUCTED OF BURIED, COMPACTED ROCK TO RESTORE NATURAL CREEK PROFILES AND PROVIDE FISH PASSAGE)
- 4. BURIED KEYWAYS**
(PREVENTS WATER IN CHANNEL FROM BYPASSING GRADE CONTROL STRUCTURES)
- 5. FLOOD PLAIN/WETLAND CREATION**
(REDUCES SPEED AND FORCE OF STORM FLOW, FURTHER REDUCING EROSION AND SEDIMENT)
- 6. REVEGETATE WITH NATIVE PLANTS**
(SLOWS WATER, IMPROVES WATER QUALITY AND PROVIDES HABITAT FOR WILDLIFE)
- 7. PROJECT MANAGES WATER FLOWS DURING STORM EVENTS**

- Realigned the creek and restored the natural flow pattern by moving the creek banks back to the east.
- Graded and terraced the channel and banks to help control erosion and sedimentation.
- Built grade control structures of buried, compacted rock to slow creek flows and allow fish to pass.
- Installed keyway structures to help prevent the creek water from bypassing the new control structures.
- Created a new floodplain and wetlands; cottonwood and willow saplings from the ranch were planted there. Also, dead cottonwoods salvaged from the creek bed were incorporated along creek banks to enhance wildlife habitat.
- All of these measures are helping manage water flows during storm events, by slowing the water, reducing its force and allowing it to flow naturally in the flood plain and new wetlands.

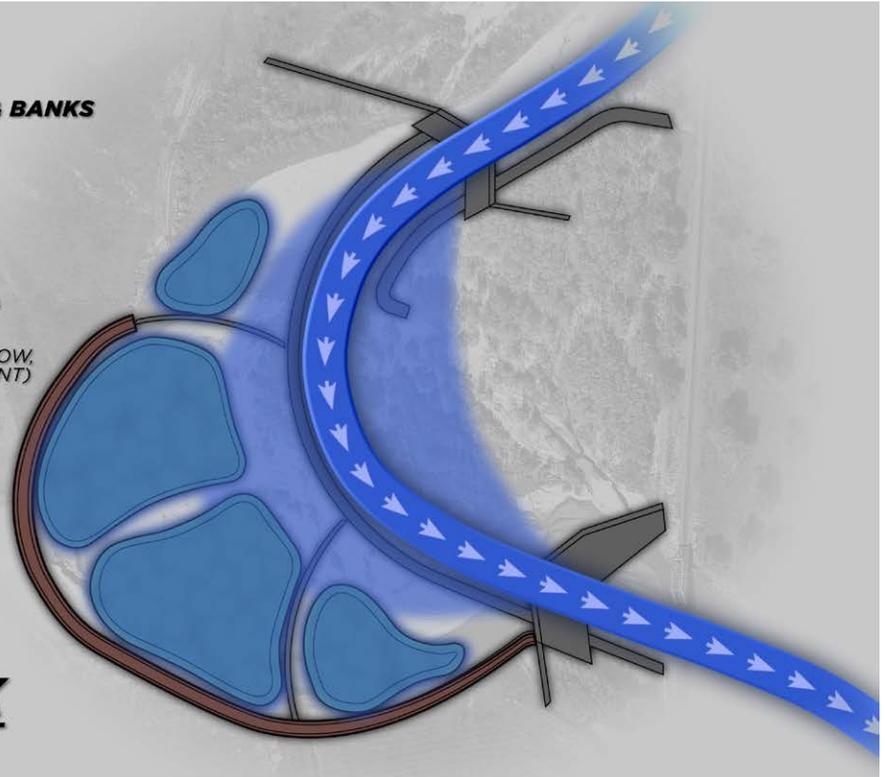
SDS contractors took a number of steps in this area to restore the creek.
